Manhole Inspection Summary

Manhole # S69M__032MH

Insp Date: 1/31/08 12:46 PM

Location Address: **6510 O'Donnell St.**

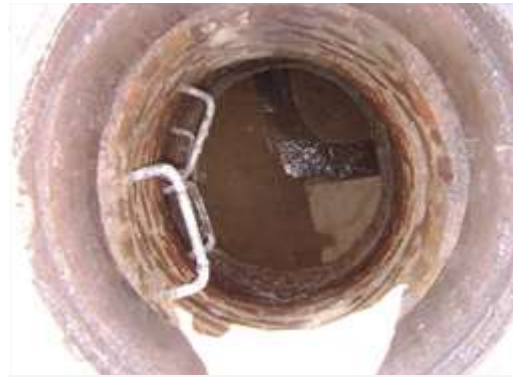
Top View

Comments **FIELD CREW VERIFIED INVERT DEPTH IS LOWER THAN OUTGOING INVERT DEPTH. THERE ARE 3 PIPES IN THIS MANHOLE. IT DOESN'T LOOK LIKE IT FROM THE TOP SIDE PHOTO, BUT THE 6 O'CLOCK IS ABANDONED.**

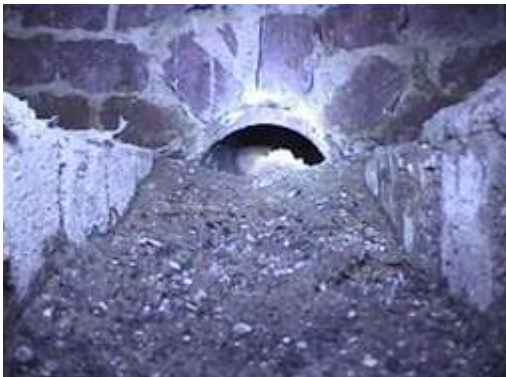
Defect 3

cracked pipe seal 11:00 above
abandoned incoming 6 o'clock

Pipe Height: **10.8** (in.) Rod and Bar (Angled)
Pipe Material: **Clay** ☐ Pipe Lined
Invert Depth: **9.88** (ft.) Flow Characteristics: **None**
Deposits: ☐ None ☒ **Mud** ☒ **Sludge** ☒ **Debris** ☐ Grease
Silt Depth: **8** (in.) Deposits Extent: **Heavy**
Infiltration: **None** Pipe Seal Cond: **Cracked**

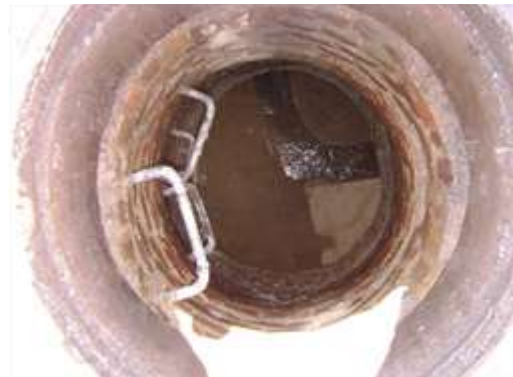
Defect 1

Bench ☒ Exists Material: **Brick** ☐ Parged
Condition: ☐ Sound ☐ Cracked ☐ Root Intrusion ☐ Deteriorated ☐ Leaks ☒ **Debris**

debris on bench from barrel wall
infiltration

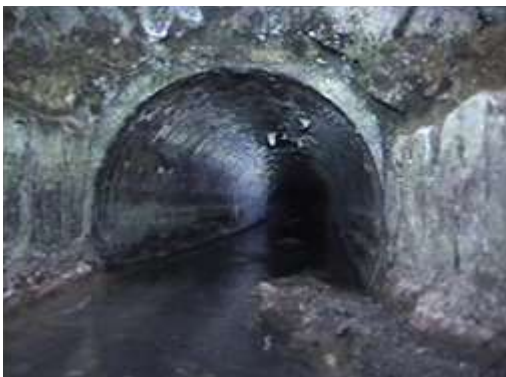
Defect 2

Barrel Material: **Brick** ☐ Parged
Shape: **Circular** Diameter: **48** (in.) Length: (in.)
Condition: ☐ Sound ☐ Cracked ☐ Root Intrusion ☐ Loose Brick ☒ **Deteriorated**
Infiltration: ☐ None ☐ Joint ☐ Cracks ☒ **Mortar** ☐ Roots ☒ **Wall**

infiltration evidence on barrel wall above
12 o'clock outgoing

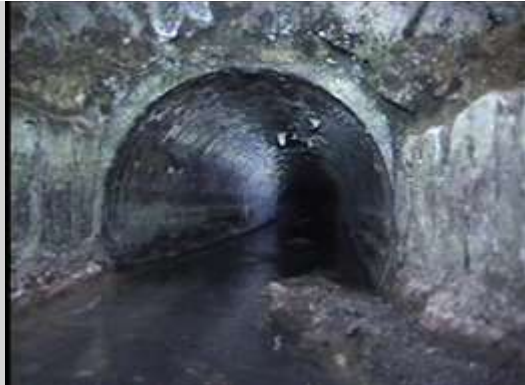
12 O'Clock Outflow

Pipe Height: **10.8** (in.) Rod and Bar (Angled)
Pipe Material: **Clay** ☐ Pipe Lined
Invert Depth: **9.88** (ft.) Flow Characteristics: **Slow**
Deposits: ☐ None ☐ Mud ☒ **Sludge** ☒ **Debris** ☐ Grease
Silt Depth: **3** (in.) Deposits Extent: **Medium**
Infiltration: **None** Pipe Seal Cond: **Sound**

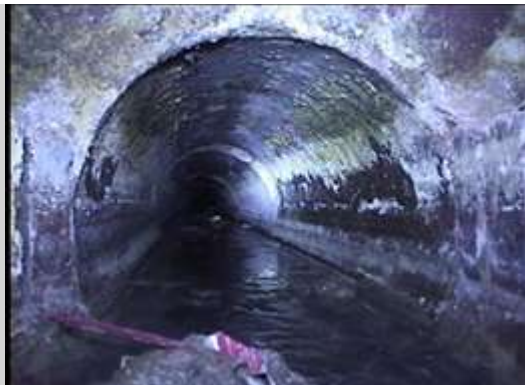
3 O'Clock Inflow

Pipe Height: **9.6** (in.) Rod and Bar (Angled)
Pipe Material: **Clay** ☐ Pipe Lined
Invert Depth: **10.00** (ft.) Flow Characteristics: **Slow**
Deposits: ☐ None ☐ Mud ☒ **Sludge** ☒ **Debris** ☐ Grease
Silt Depth: **3** (in.) Deposits Extent: **Medium**
Infiltration: **None** Pipe Seal Cond: **Sound**

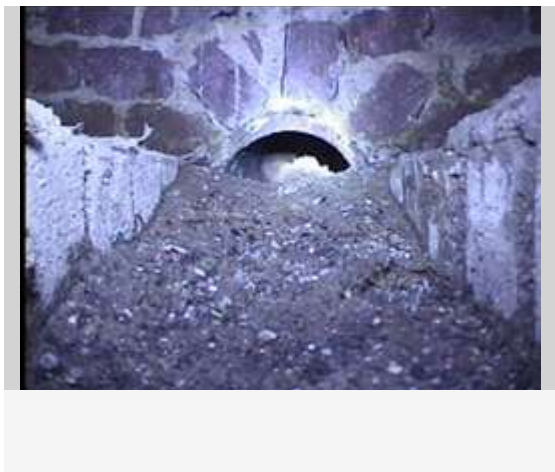
6 O'Clock Inflow

Connects To: **Stub connection / abandoned**
☐ Possible Illicit Connection
